OTWAY WATER BOOK 66

Crit on "Assessment of historical and current vegetation diversity and condition in Big Swamp." 18 December 2019,

prepared by Eco Logical Australia as part of the 2019 remediation of the Big Swamp Wetland Being Conducted by Barwon Water.

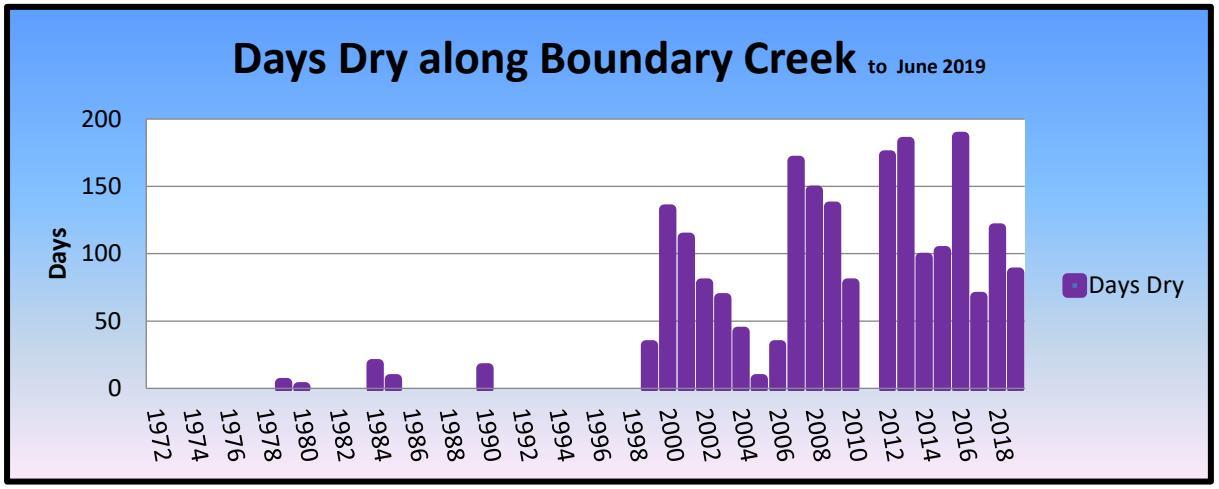
<u>SOURCE</u>: Barwon Water/ Vic Water Warehouse. Graph Two.

This statement does not match the ceases-to-flow events as recorded in Barwon Water and the Vic Water warehouse documentation (Also, see pages **26-27**).

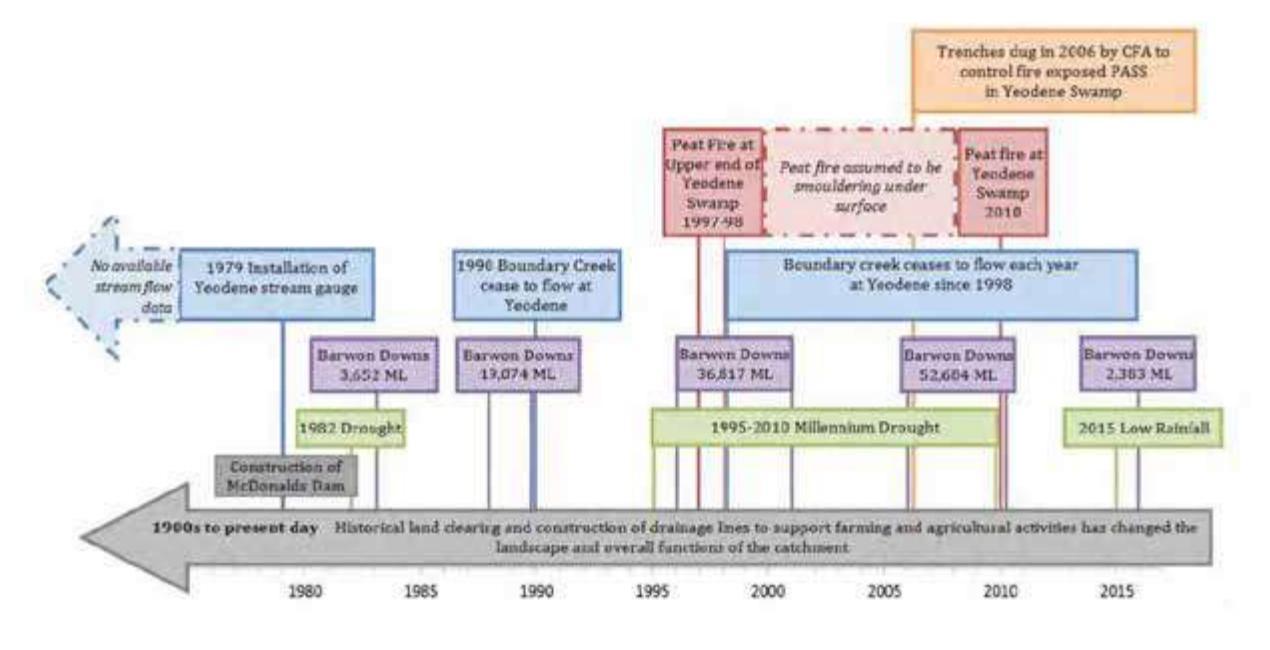
Figure 3-1 in the Eco Logical Australia's report contains discrepancies.

- 1. Witebsky et al.⁽²⁾ calculated that the 1982-83 drought extractions amounted to around 8,000 ML. Not 3652 ML.
- 2. There were cease-to-flow events after the 1982-83 extractions and before the 1990's.
- 3. Up to 1997 there had been an extremely wet period followed by a dry period 1997-2001. Not 1995 to 2010 (see Healey rainfall chart above).
- 4. In 2011 Boundary Creek did not cease-to-flow.
- 5. Page 9 states in 2016 Barwon Water extracted 3,449 ML. Not 2,383 ML.

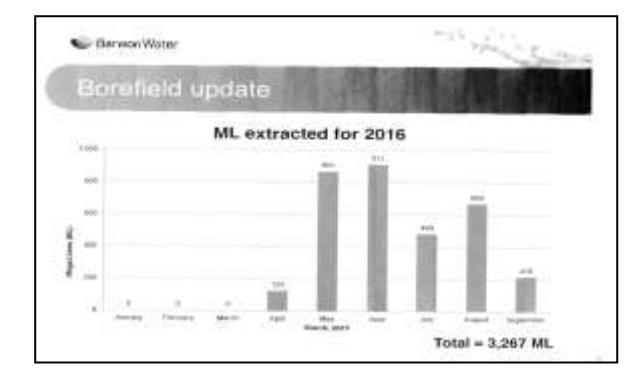
This Barwon Water document gives the 2016 extraction figure as 3,267ML. See Appendix One for the full year of extractions for 2016.

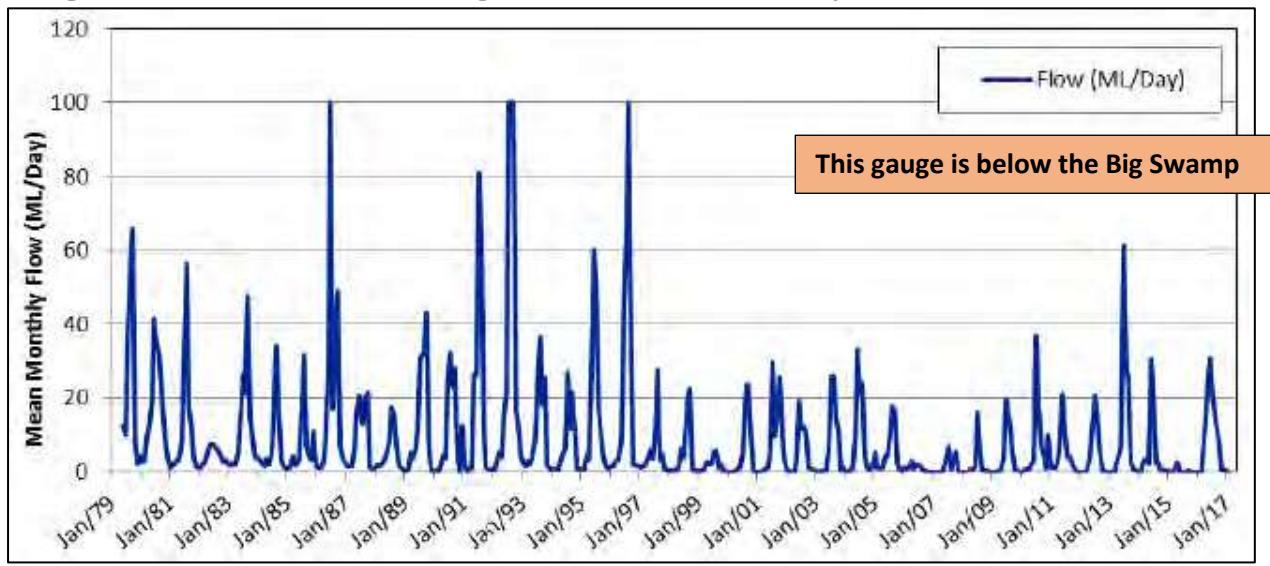
Page 11 of the Eco Logical Australia report.

SOURCE: Eco Logical Australia. Figure 3-3. Average monthly flow in Boundary Creek at Yeodene (Jacobs 2017)

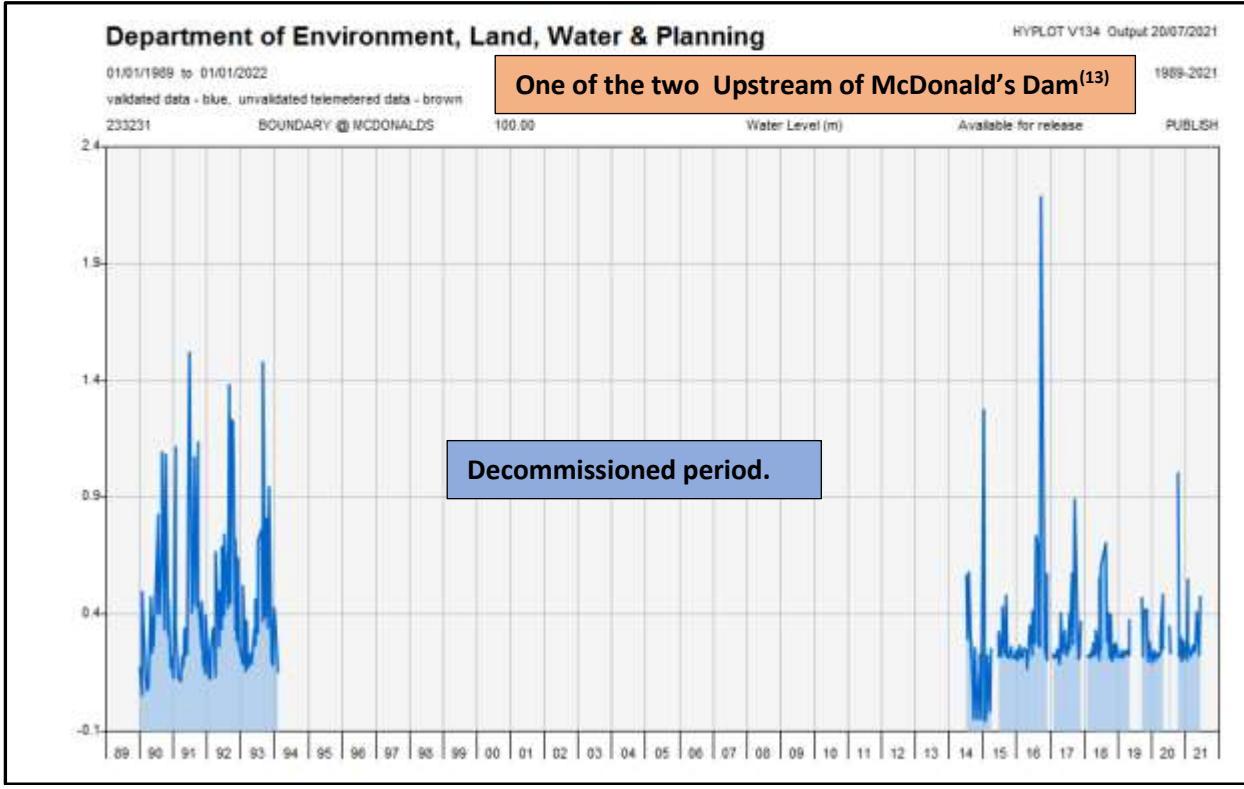
SOURCE: Vic Water Data Warehouse. (Extract from Otway Water Book 41)

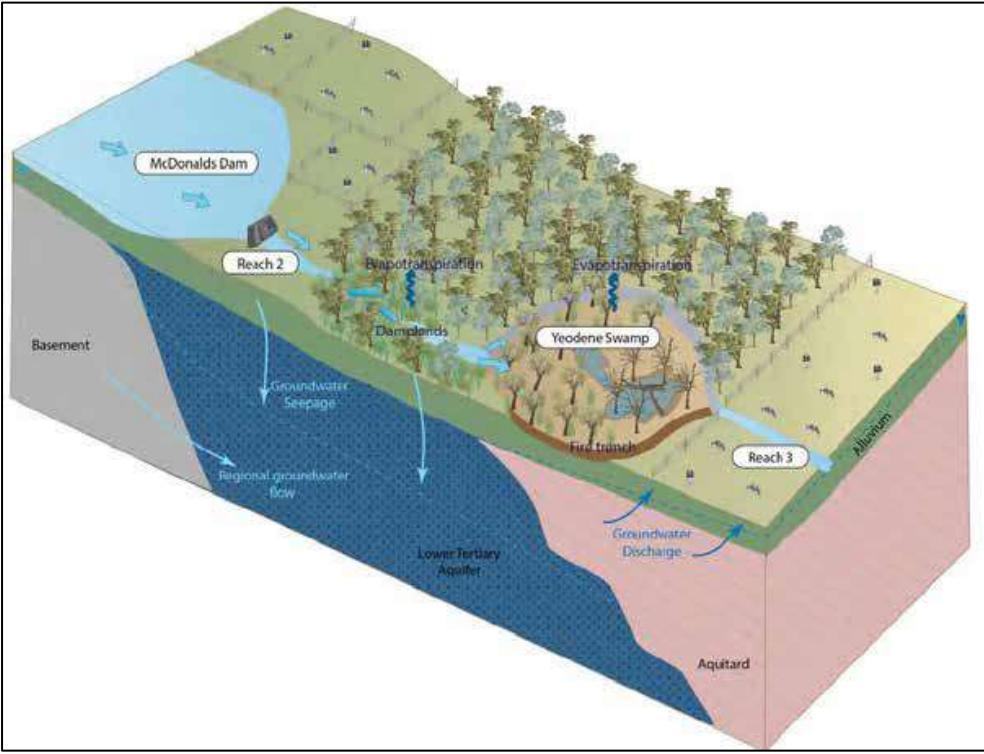
SOURCE: Eco Logical Australia. Figure 3-5. Working conceptualisation of the hydrogeology of Big Swamp (Jacobs, 2017)

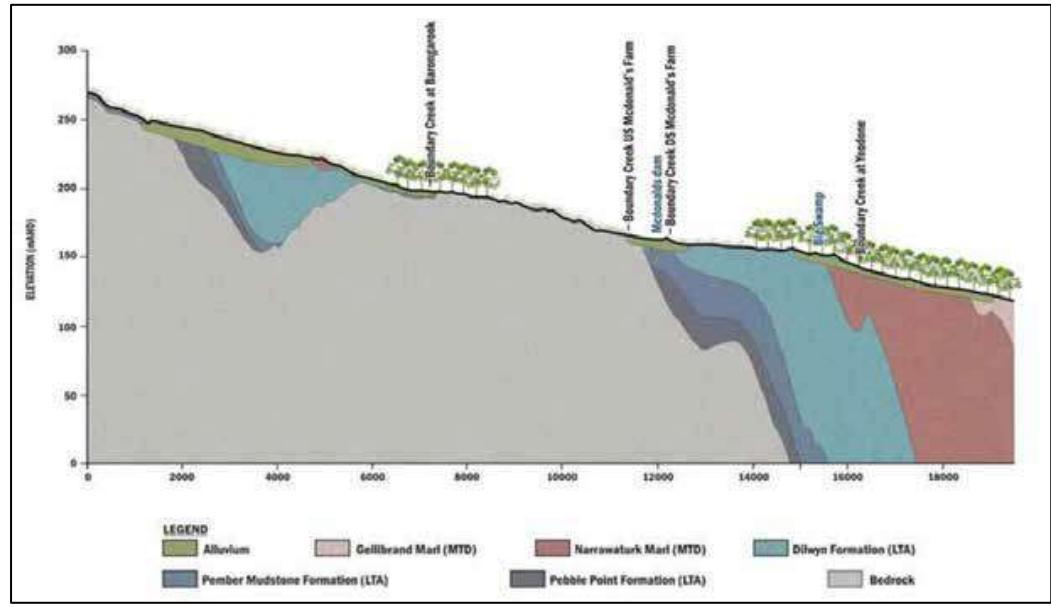
SOURCE: Eco Logical Australia. Figure 3-6. Long section along Boundary Creek (Jacobs 2017)

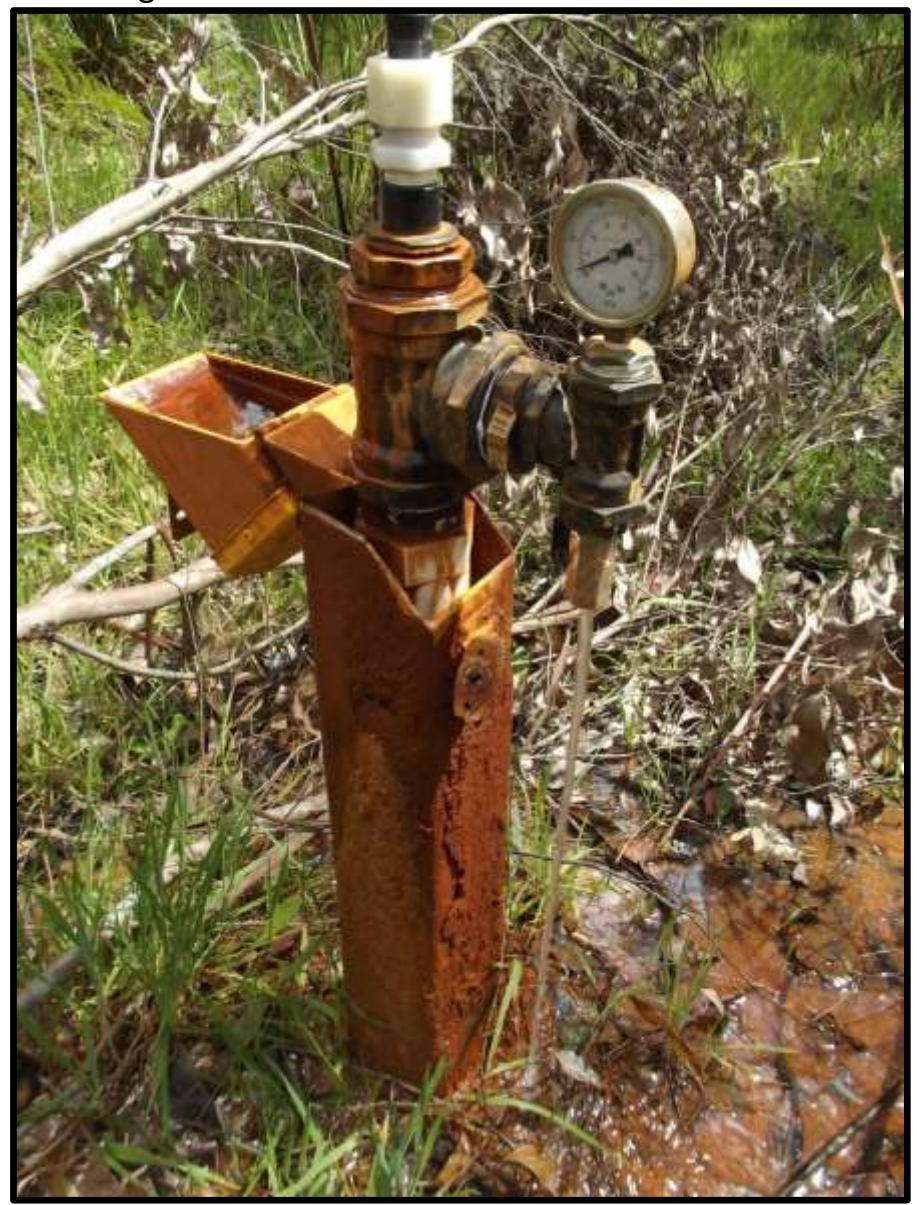
Photograph showing artesian flow at the east end of the Big Swamp (1 Nov. 2021).

Furthermore, it would appear that the authors of this document have not been informed that the Lower Tertiary Aquifers have recovered to artesian levels at the eastern end of the Big Swamp. This would have some influence on the second part of this statement but what the rest of the statement means is very confusing.

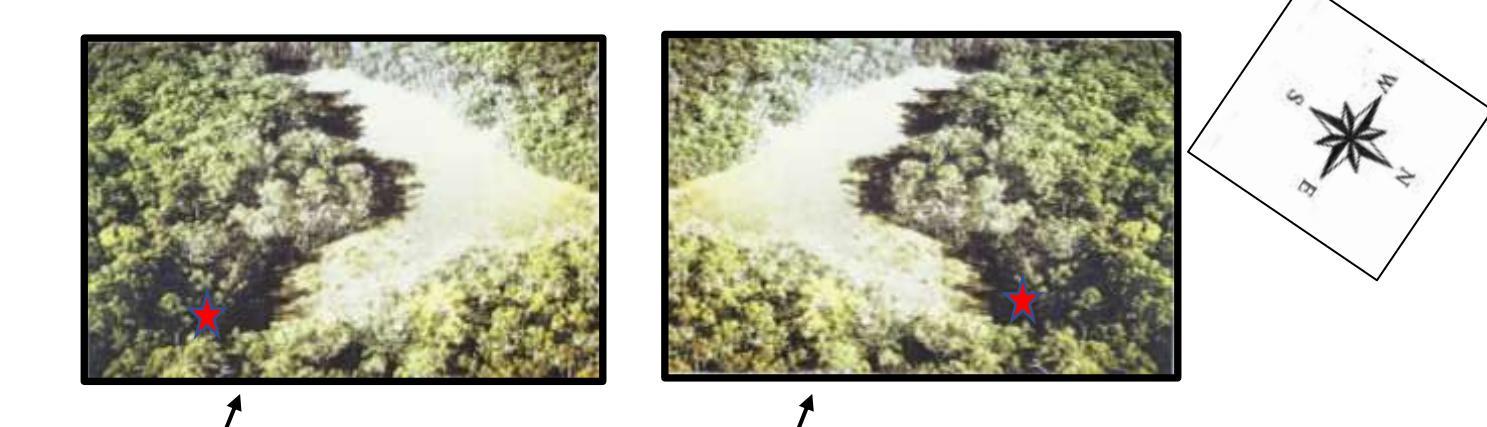
Plate 9, in Carr and Muir 1994, and the flipped horizontally version that matches aerial photographs below, Google Earth and the direction of southern hemisphere shadows.

"An aerial image of sub-community 6.2 taken in 1993 is provided in Plate 3." The aerial image was printed the wrong way around as explained below.

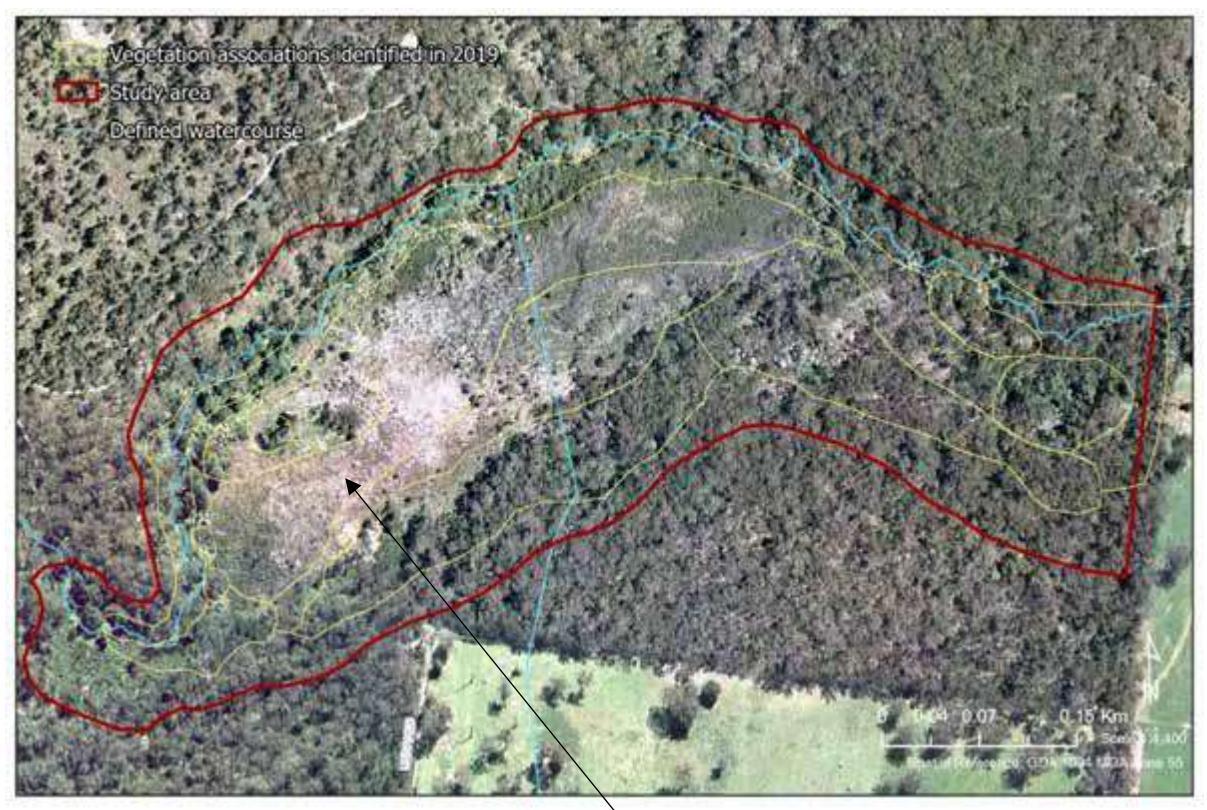
Source: Eco Logical Australia. Figure 3-13 Aerial imagery of the Big Swamp from 2004.

a. The vegetation in the site of the 1997 fire had not recovered. These conditions persisted and vegetation impact continued right up to the 2010 fire. The 1997 fire site was still a barren hydrophobic site as seen in 2009 (person observation).⁽¹⁾

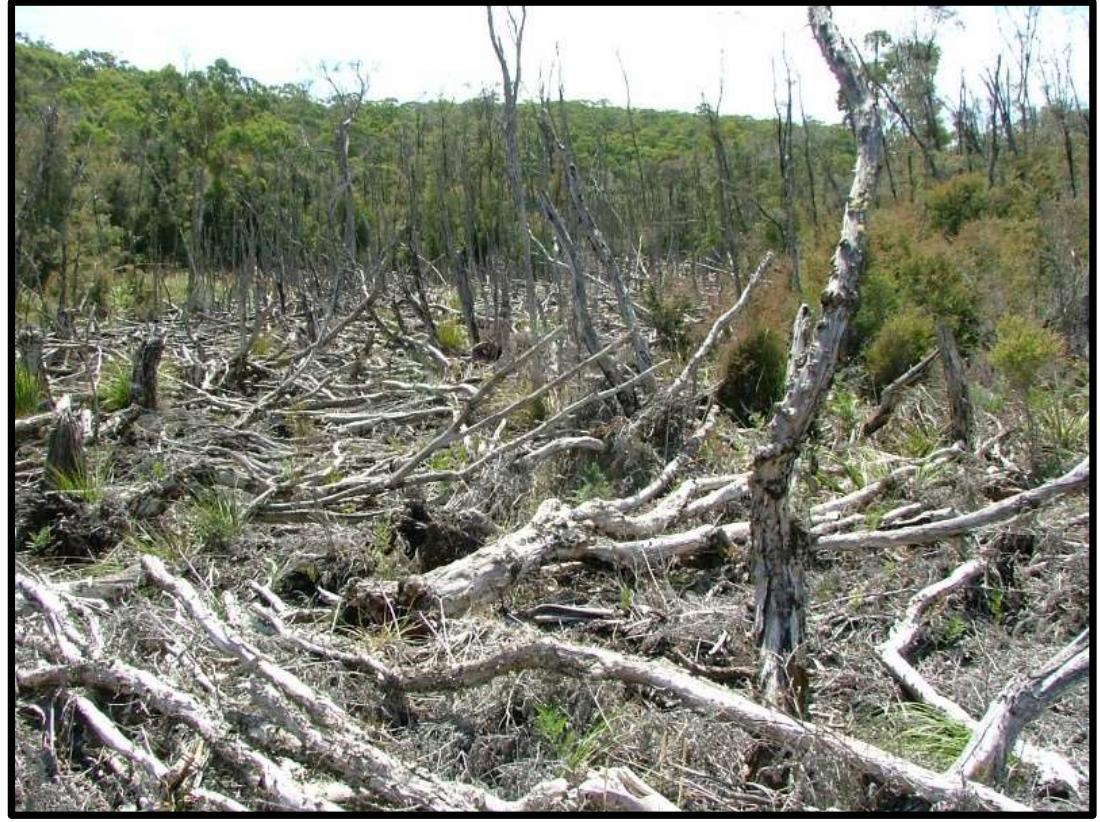
Water at this site was tested as low as 2.5 pH.

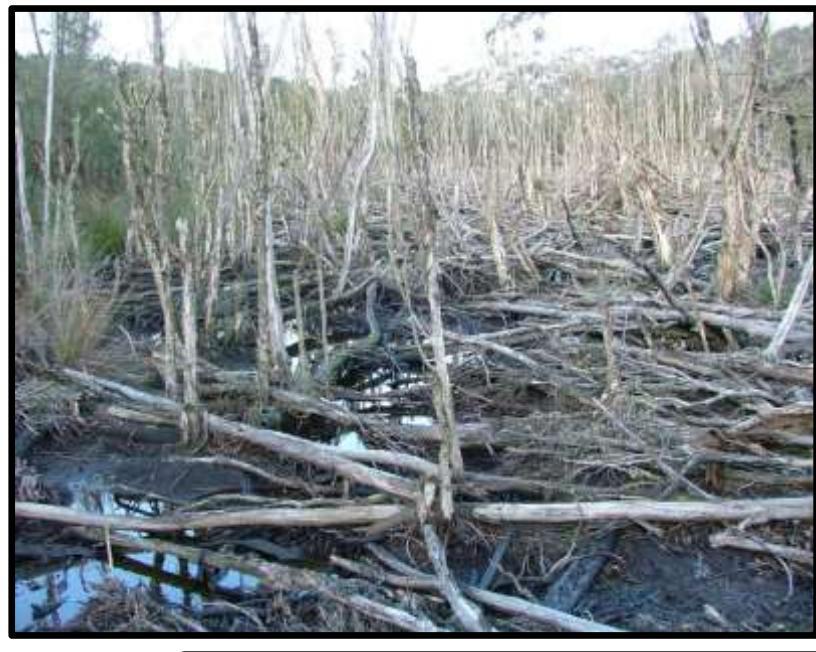
In places the windthrown vegetation was over a metre deep. Tall unhealthy Melaleuca squarrosa trees on the verge of this site could be easily pushed over by hand.

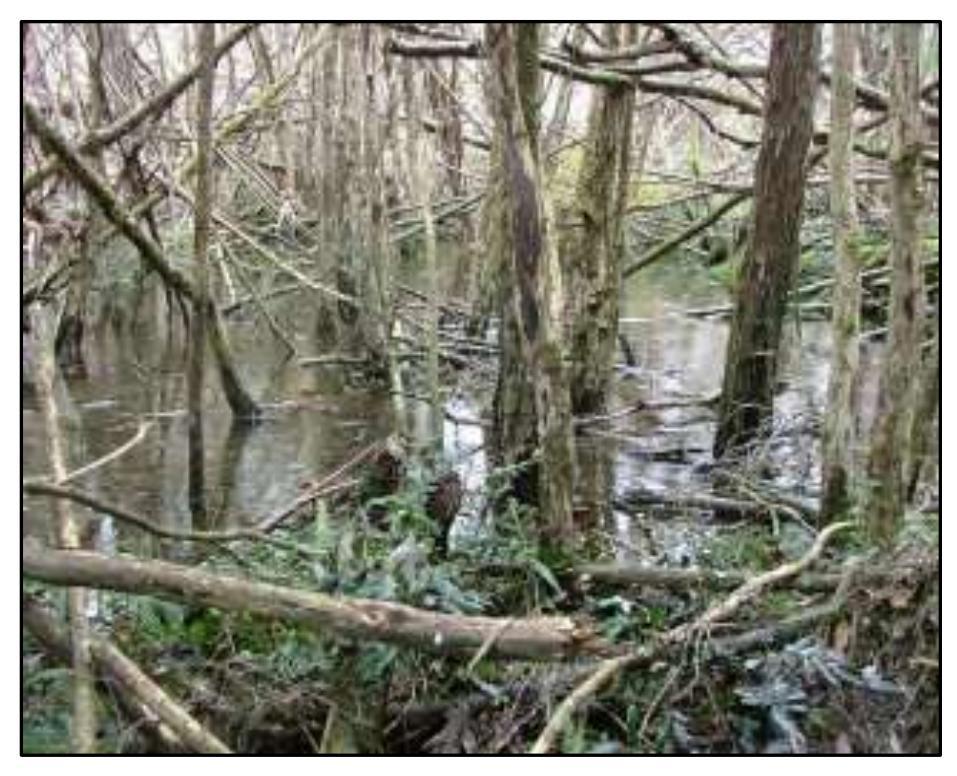
The pH at this site at the eastern end of the Big Swamp was 2.3 pH.

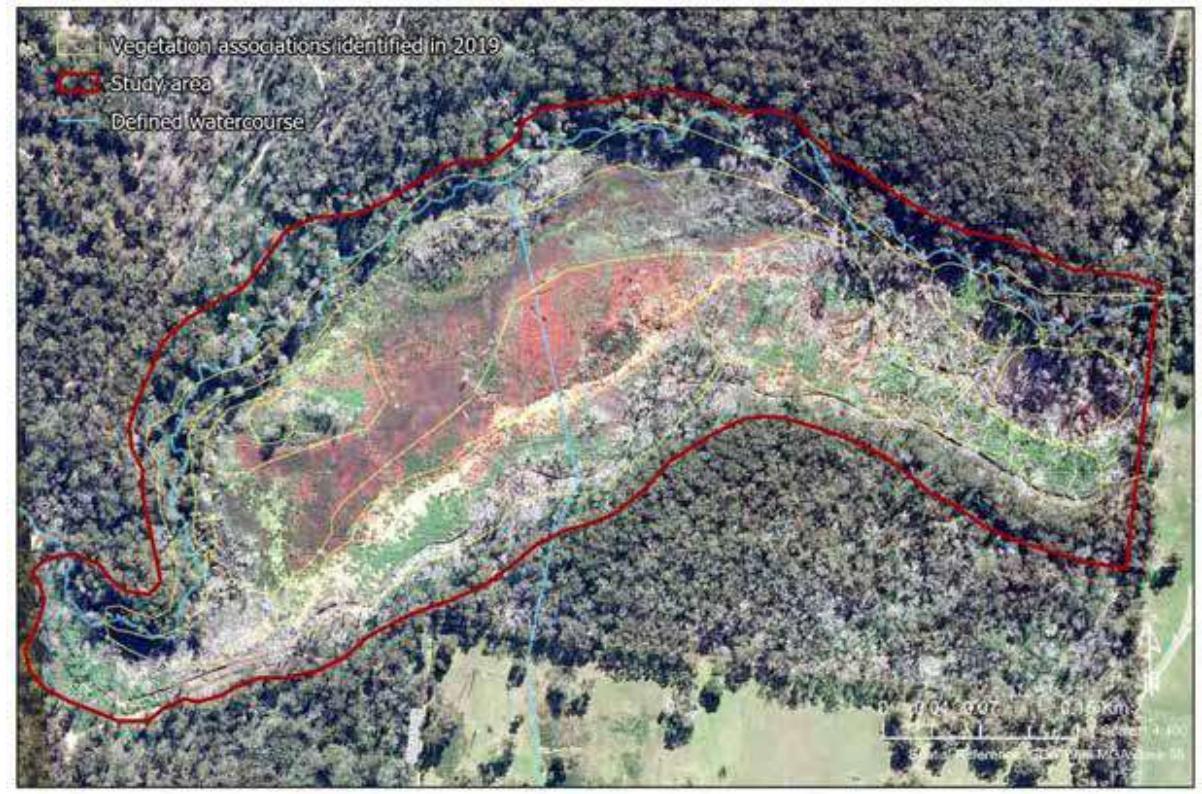
6. This 2011 imagery gives an indication of the impact from the 2010 fire.

Source: Eco Logical Australia. Figure 3-14 Aerial imagery of the Big Swamp from 2011.

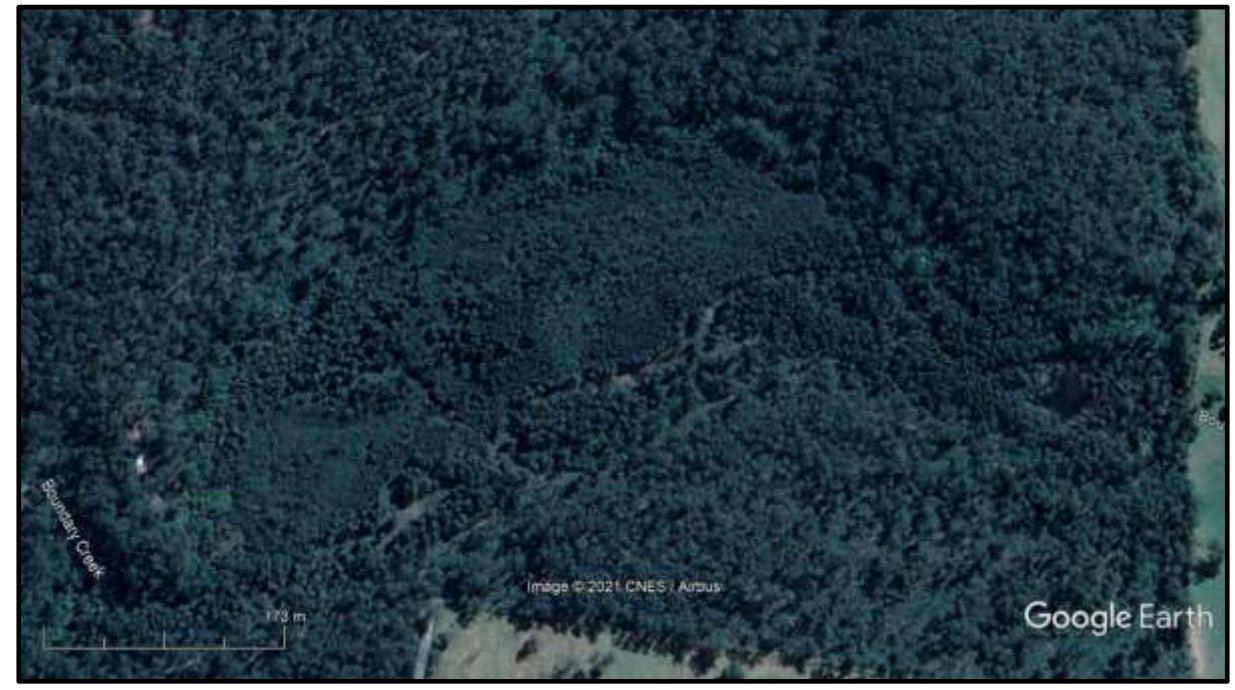
7. This image below taken from Google Earth October 2021 shows an aerial image of a vegetation cover not that dissimilar to the Eco Logical Australia 1969 image, Figure 3-11 seen on page 20 above.

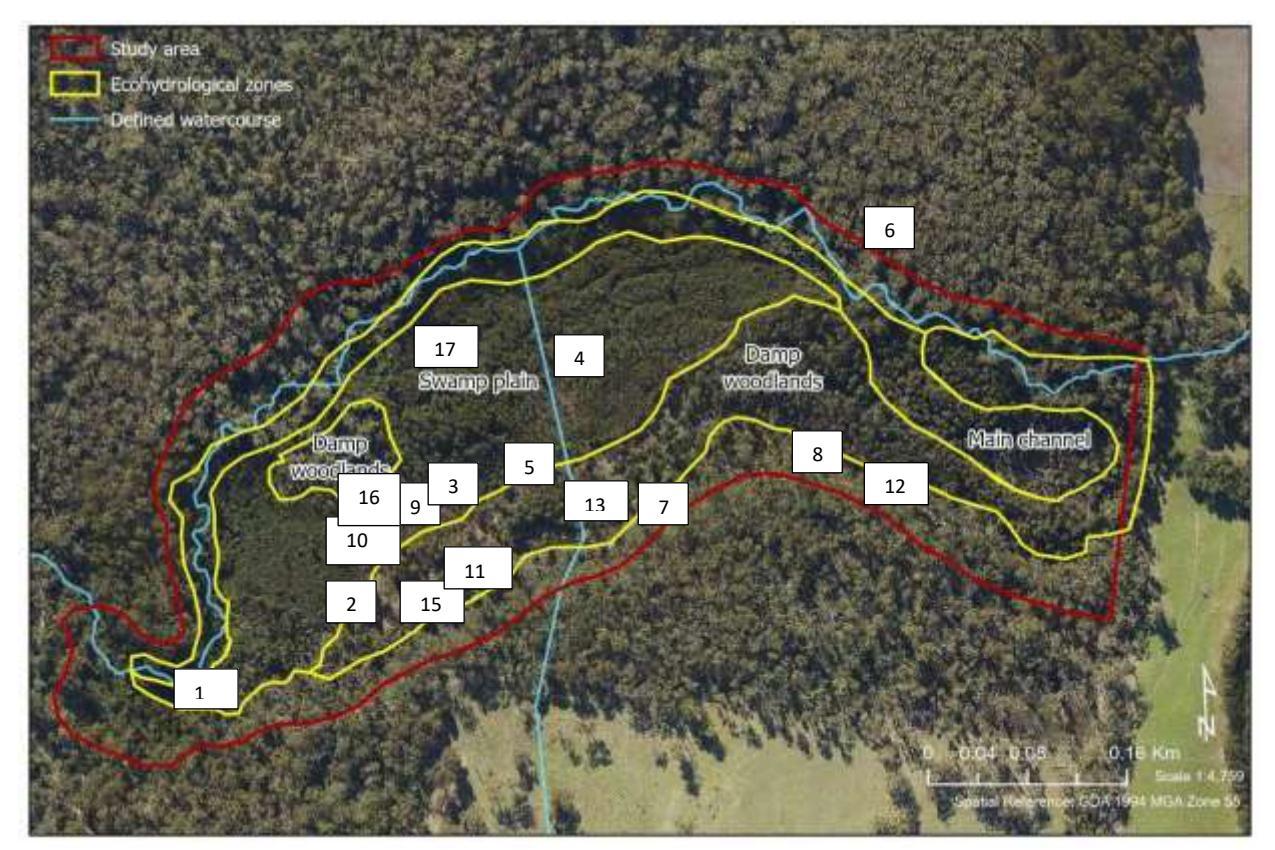
Figure 4-1. Ecohydrological zones within the Big Swamp

The location of the site where the following photographs were taken have been marked on Figure 4.1 taken from **Page 44** of the Eco Logical Australia report.

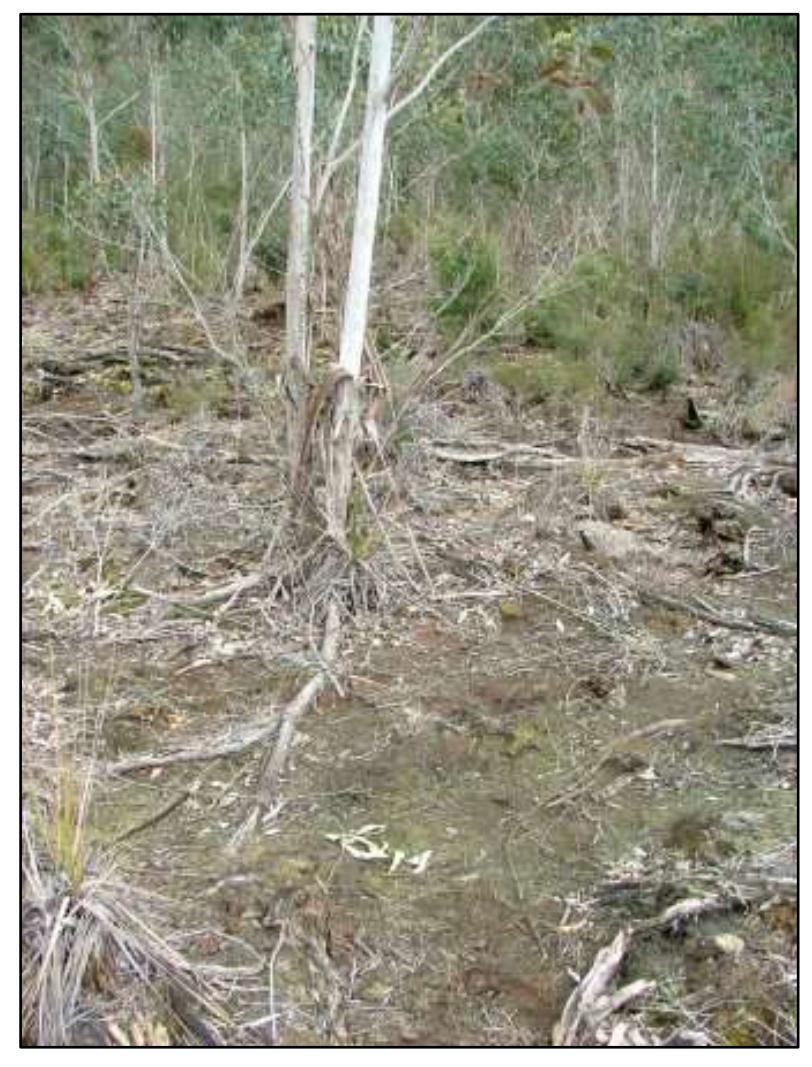
These trees were relatively easily pushed over. However, after the 2010 fire the first lot of eucalyptus and other flora species that attempted to re-colonise the swamp survived for only a short period, died and then tried again the next season. In some areas of the Big Swamp it took some seasons for these plants to survive.

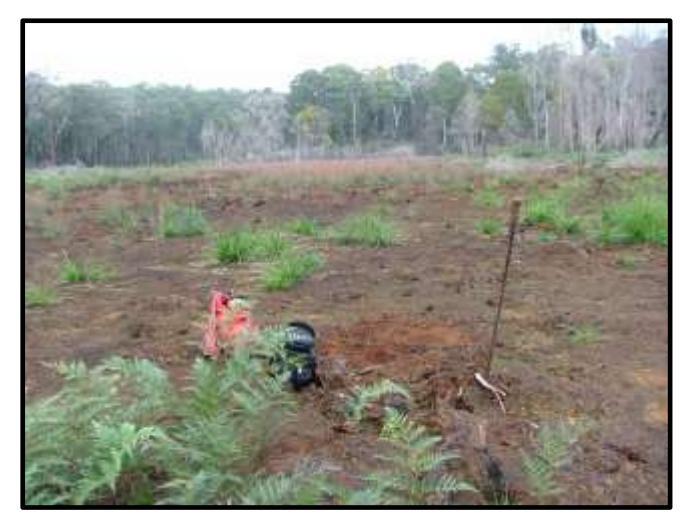
Photo 3.

This photograph was taken 20 months after the 2010 fire looking west across the Swamp Plain section (taken on 8 November 2011). The green foliaged trees in the background are south of the southern fire trench that had been dug around the Big Swamp (see pages 33, 34, 35 and 37 below).

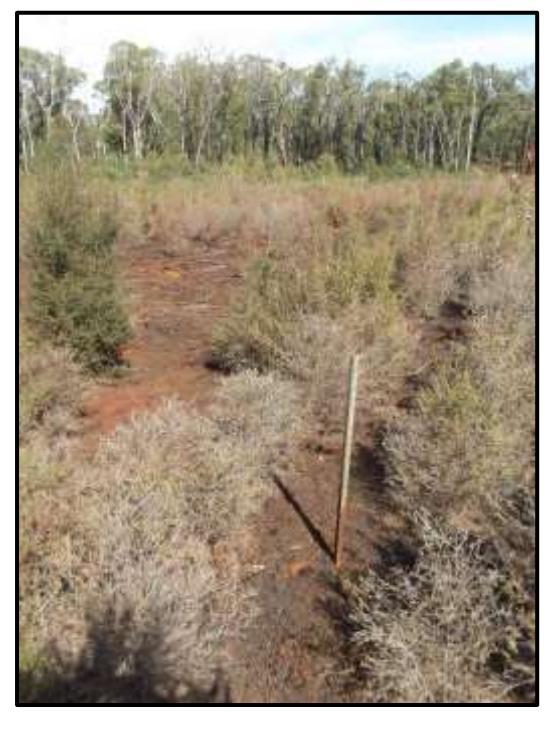
Photo 10.

This galvanised steel dropper appeared in the Big Swamp around the same time Ecology Australia conducted the 2008-09 vegetation survey for Barwon Water. Similar droppers were placed at all other sites visited and recorded. However, no record of a visit being made to the Big Swamp has ever been admitted to.⁽⁵⁾

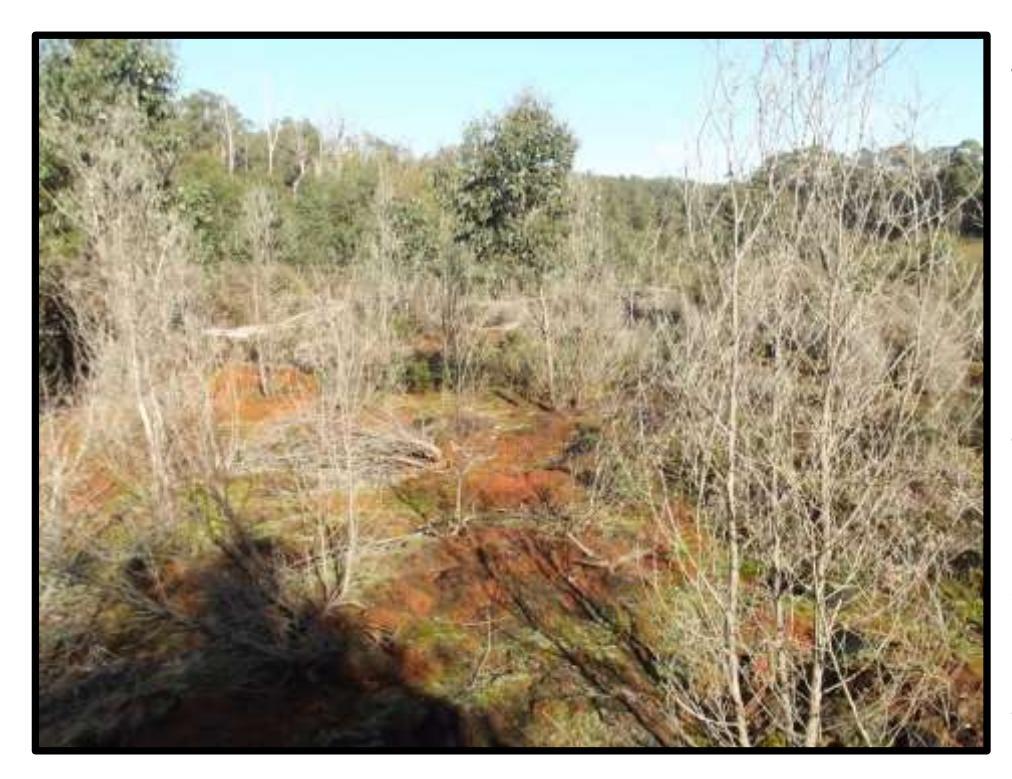
Photo 11. This photograph was taken at the west end of the Damp Woodlands looking west on 25 May 2014 and shows an area that has really struggled to support the growth of eucalyptus and most other vegetation.

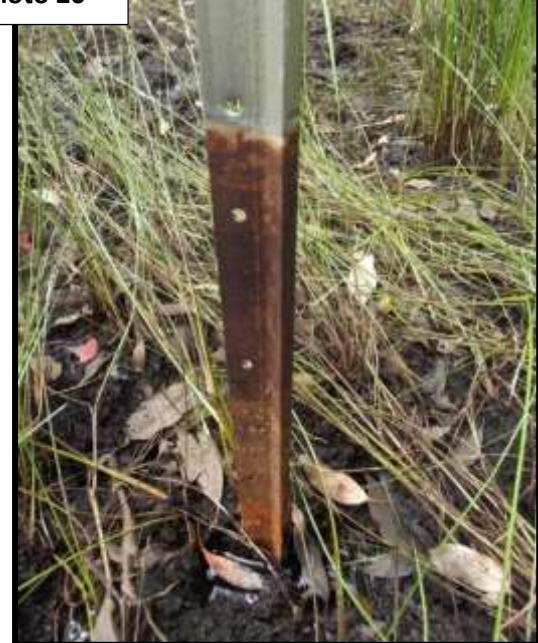
This is the galvanised steel dropper placed at Site 79 during SKM's 2008 vegetation survey⁽⁶⁾ in Boomerang Swamp. The dropper shows the amount of corrosion in just two months of inundation.⁽⁴⁾⁽⁵⁾

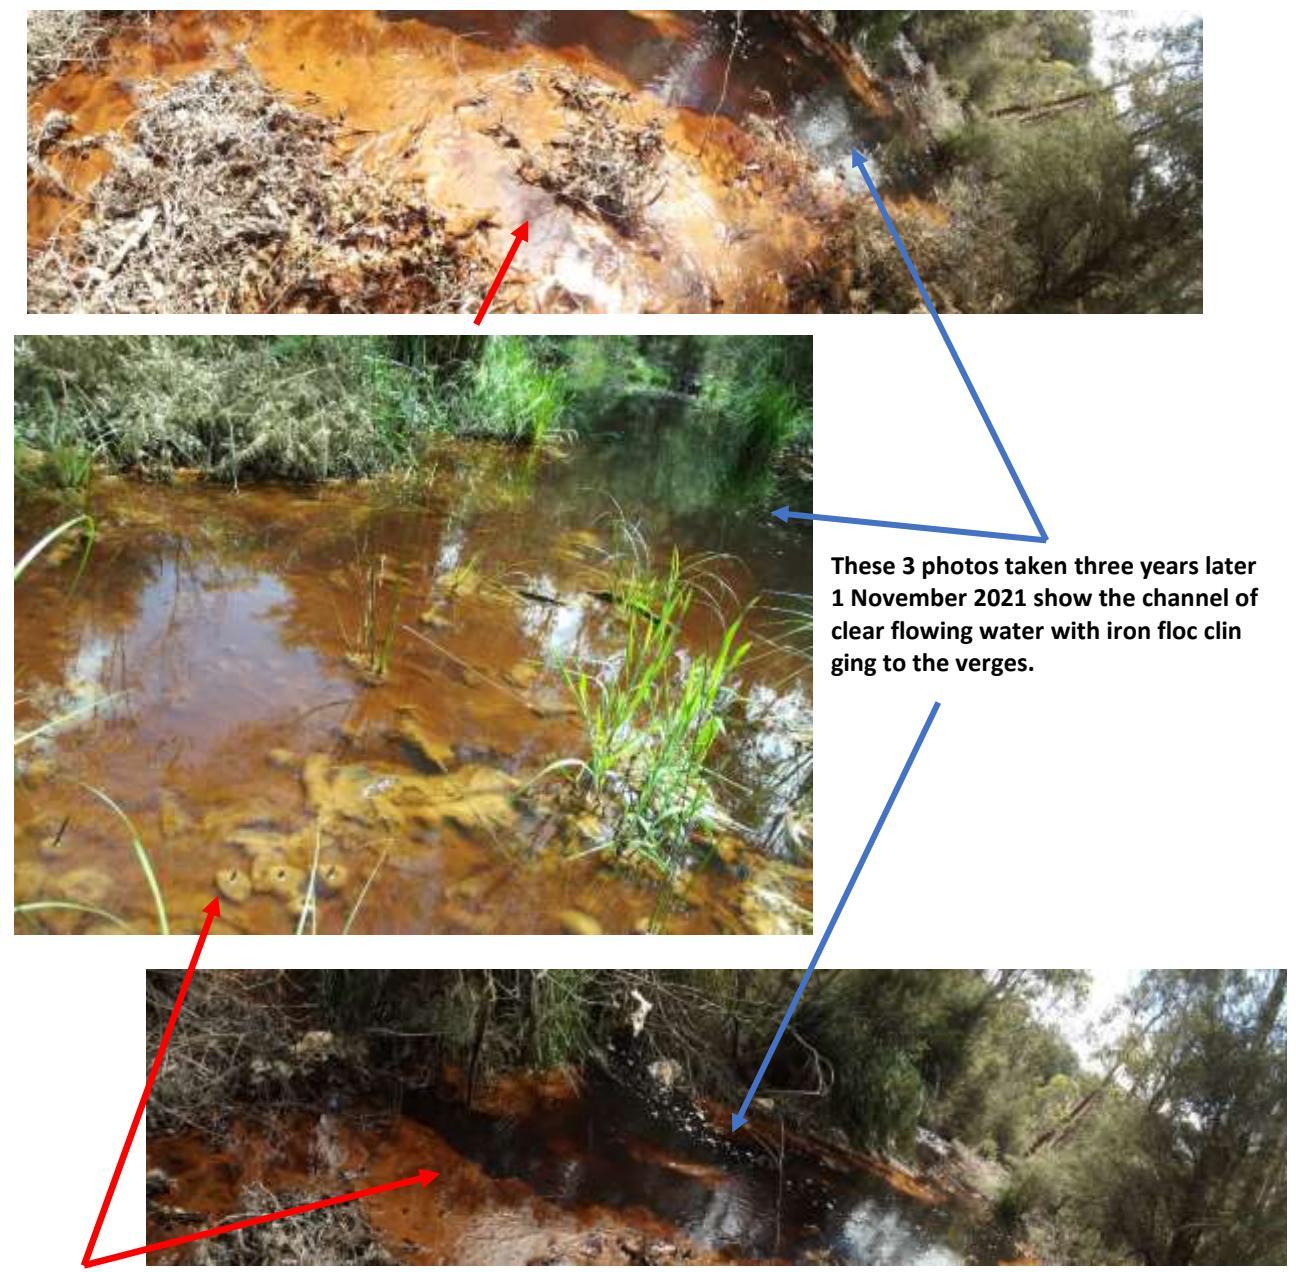
Floc has accumulated on anything that is not being swept away by the stream of water. The edge between the flowing water and the floc is very pronounced.

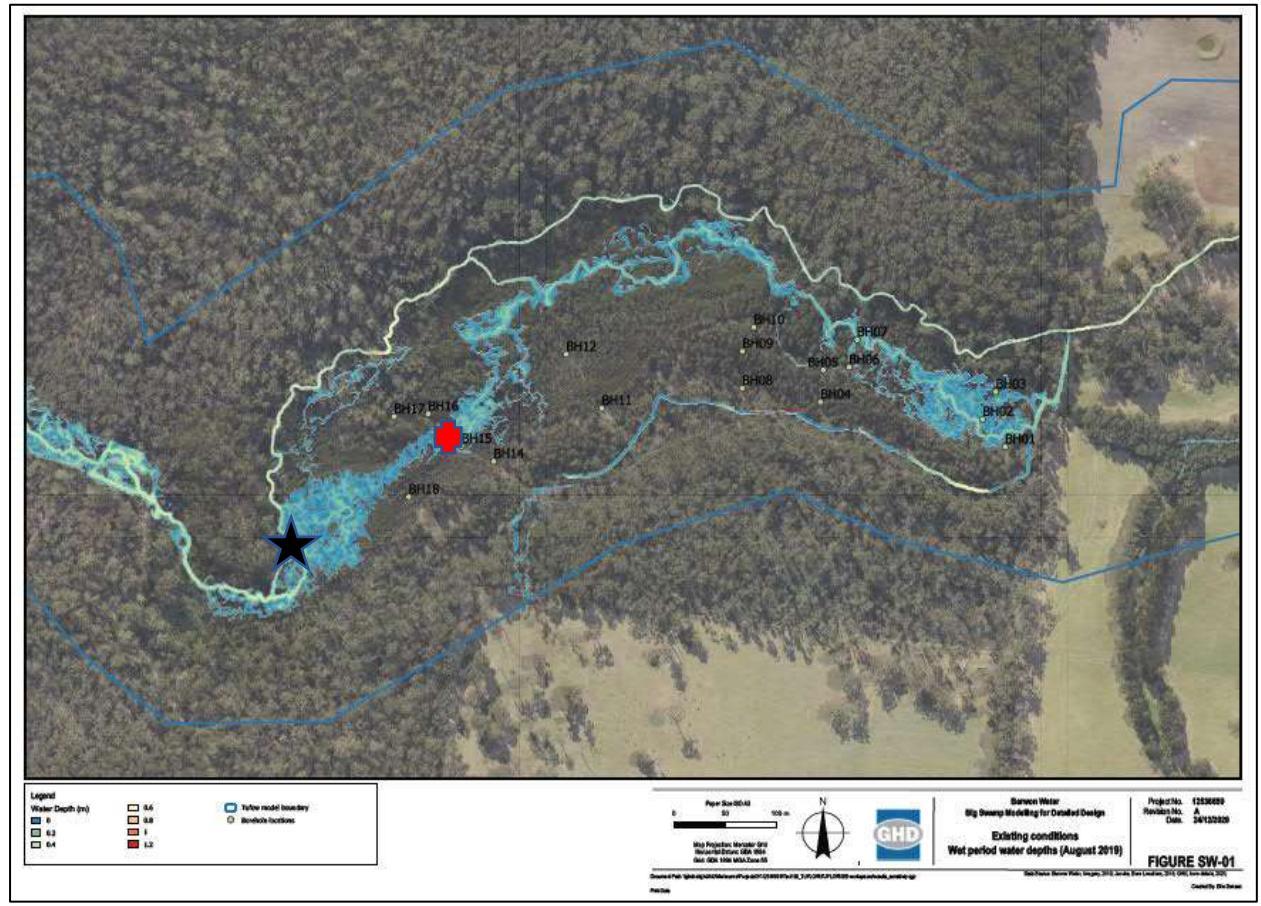
Source: Barwon Water 2020-2021 Remedial Environmental Protection Plan report, page 32.

This overhead of the Big Swamp indicates the flow of water through the swamp. I walked across most areas of the swamp wetlands on 1 November 2021 and found the no evidence of scouring or erosion of or deepened flow paths.

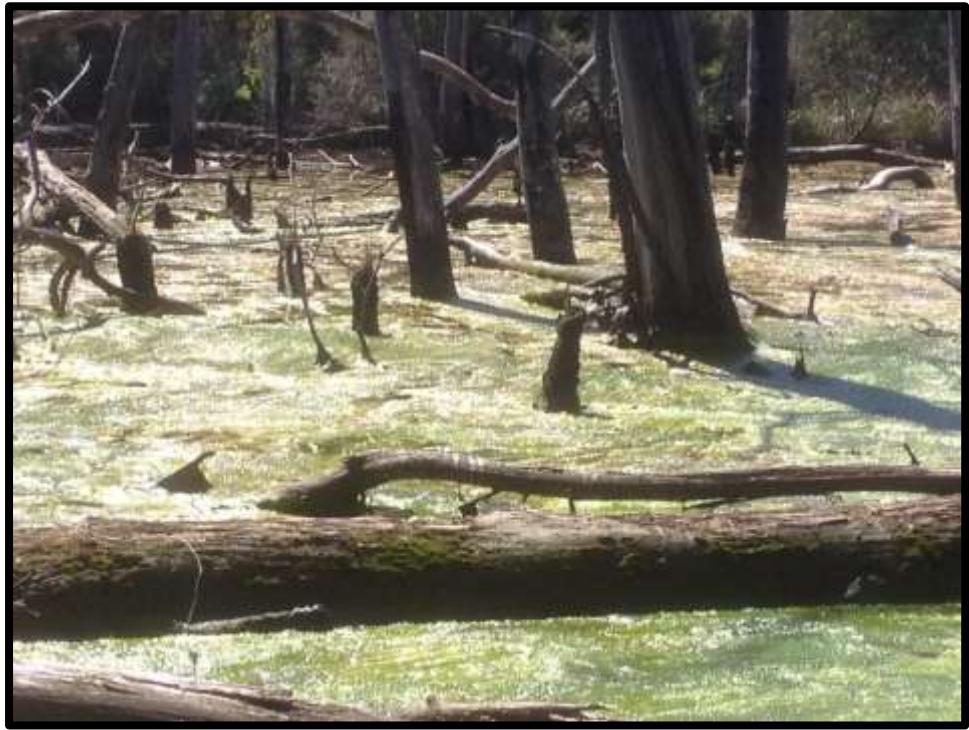
October 2018. Pooling just above the east fire trench.

The digging and placing of the soil from the east fire trench on the western side of the trench would have forced any flows through the area to back up in this part of the Big Swamp. This could have been recognised as the sediment plug in 2019. Not a plug caused from erosion back through the swamp.

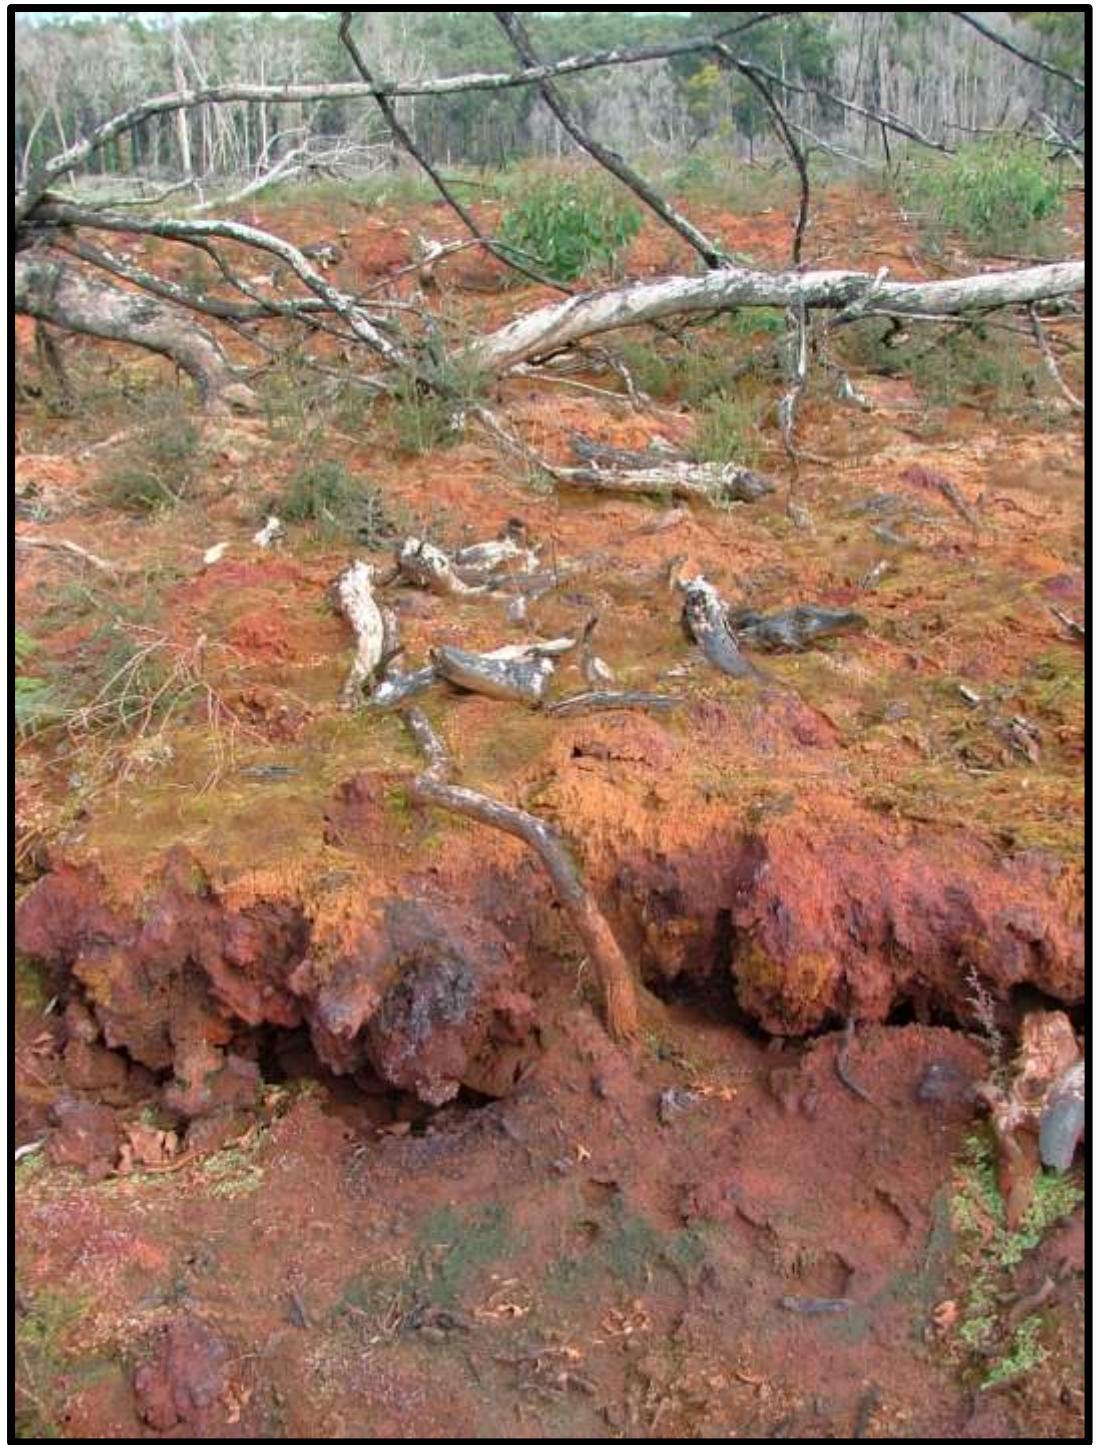
8 November 2011. Slumping and burning impact not soil erosion.
